HISTORIC AMERICAN TIMBER-FRAMED STEEPLES

V. Engineering a Steeple Restoration

ST. MICHAEL'S EPISCOPAL CHURCH in Charleston, South Carolina, was built by Samuel Cardy between 1752 and 1761. Its architect unknown (possibly Cardy), it follows English pattern book designs popular in the Colonies and somewhat resembles James Gibbs's design for St. Martin-in-the-Fields in London. St. Michael's survived wars, hurricanes, tornadoes, fires and the 1886 earthquake. During the Revolutionary War it was a center of American resistance and the tower was a target for British naval gunners. The 186-ft. steeple served as an observation post and navigational landmark in this and later military conflicts. As a result of the 1886 earthquake, the steeple settled 8 in. with the spire leaning 18 in. away from the nave toward Meeting Street, requiring reconstruction of the portico below. Repaired cracks in the brick masonry can be observed today from the inside of the tower (Fig. 1).

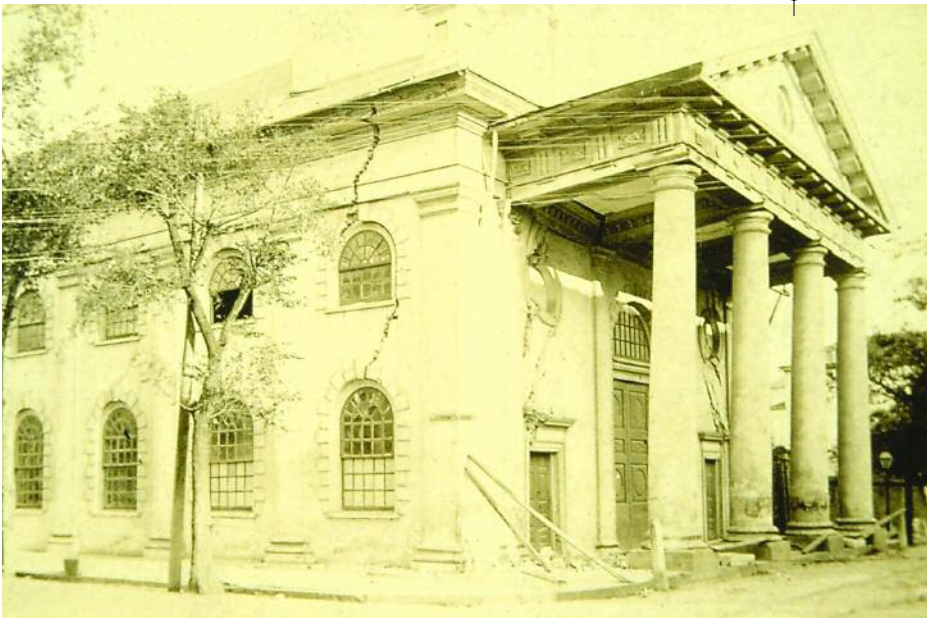
Fig. 1. St. Michael's after the 1886 earthquake. Portico leaning toward Meeting Street was rebuilt and large cracks in first bay repaired.

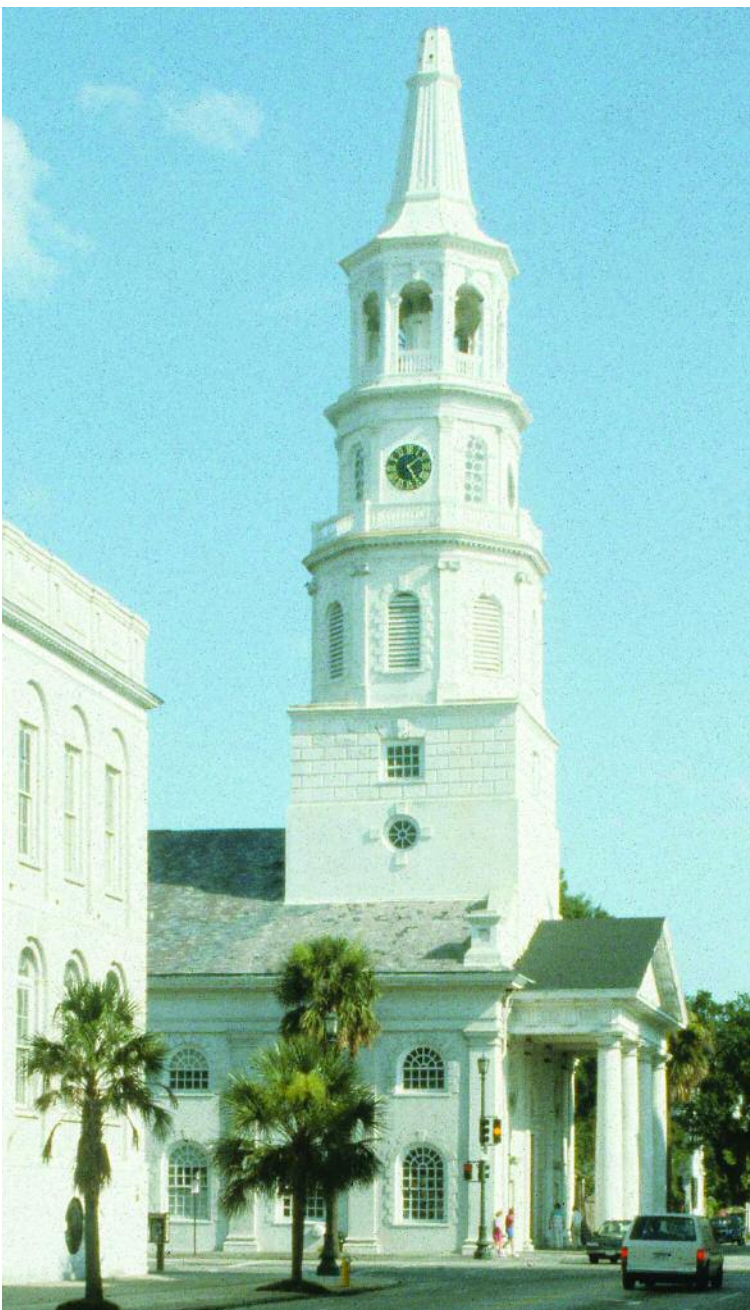
Fig. 2. St. Michael's in 1996, steeple 186 ft. tall, of which 111 ft. are masonry. Open lantern and spire are wood framed. Ball and weather vane not yet restored to spire.

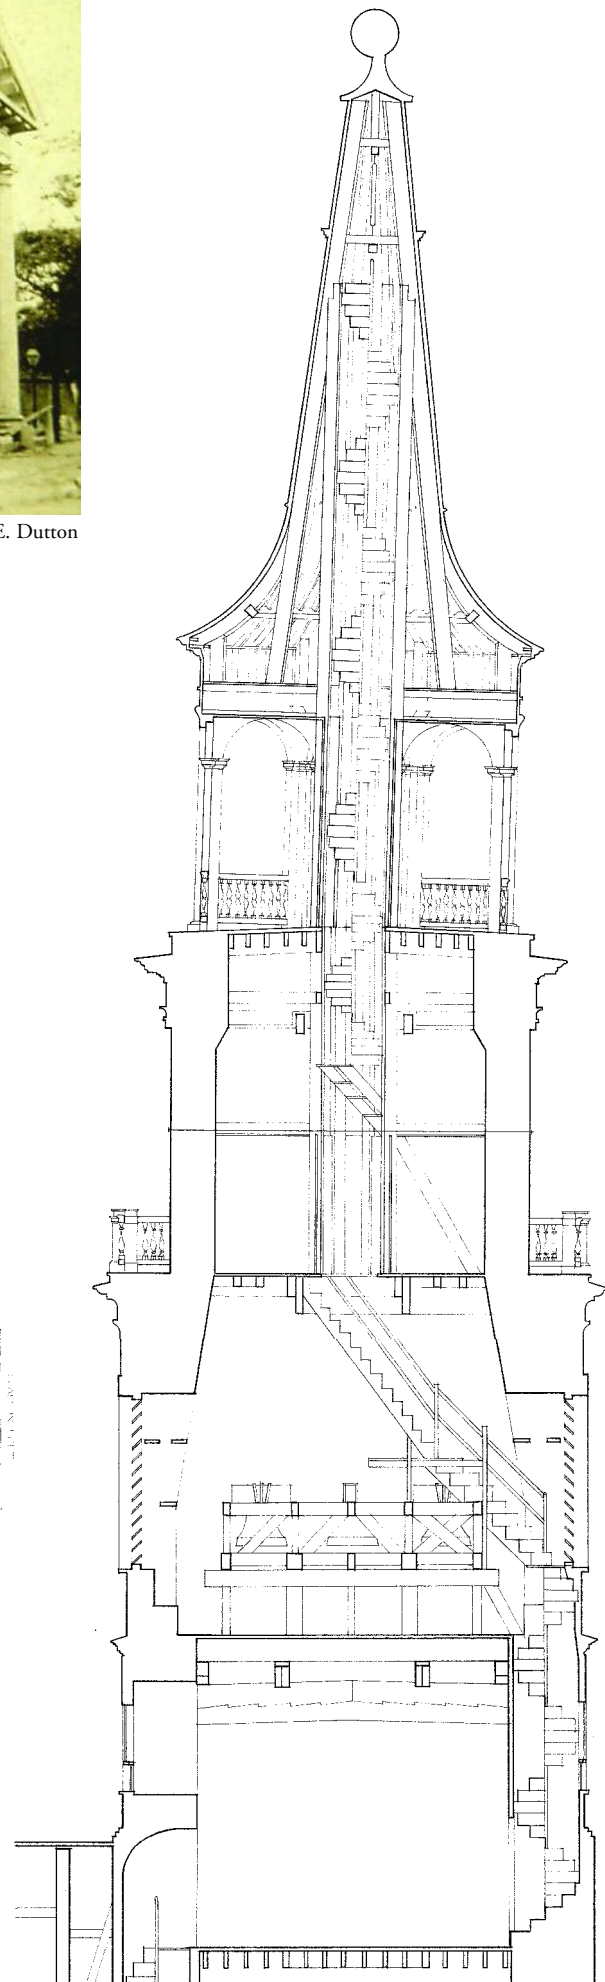
Fig. 3. St. Michael's cutaway steeple elevation looking south. Historic American Buildings Survey, 1963, drawn by Mark W. Steele. Spire and lantern shown listing west, toward Meeting Street.

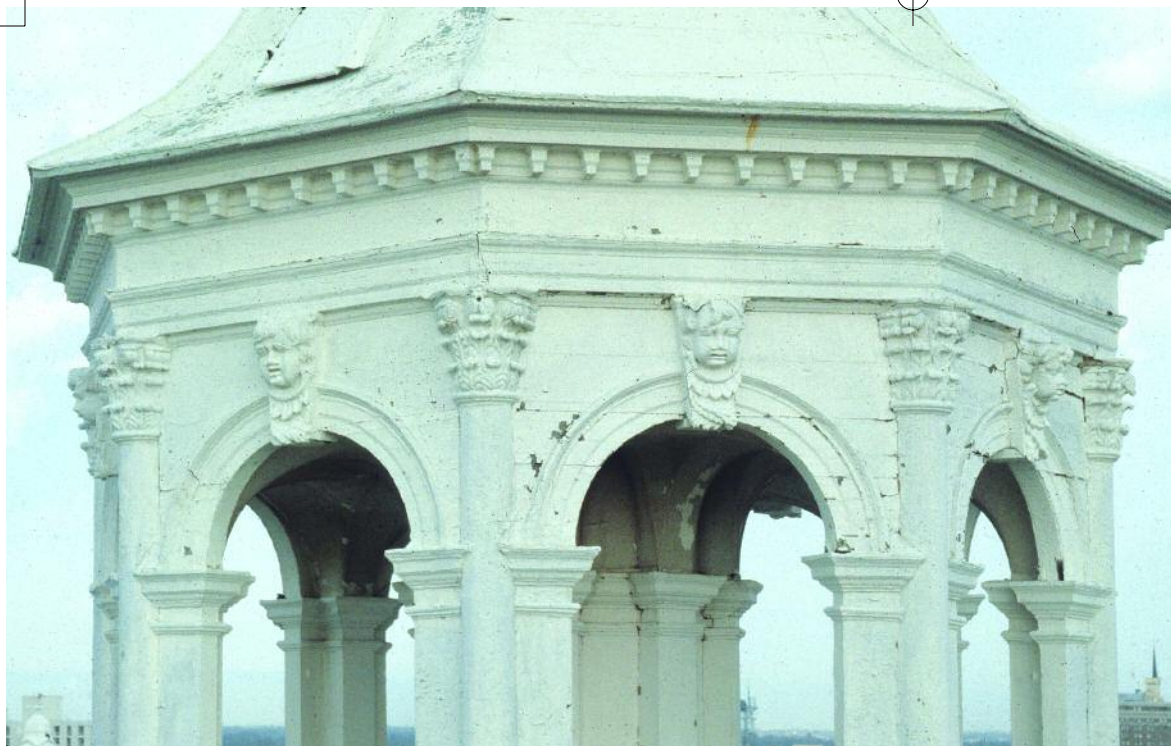
Fig. 4. Decorated lantern conceals perimeter posts, portal framing and core of timbers extending down to clock stage.

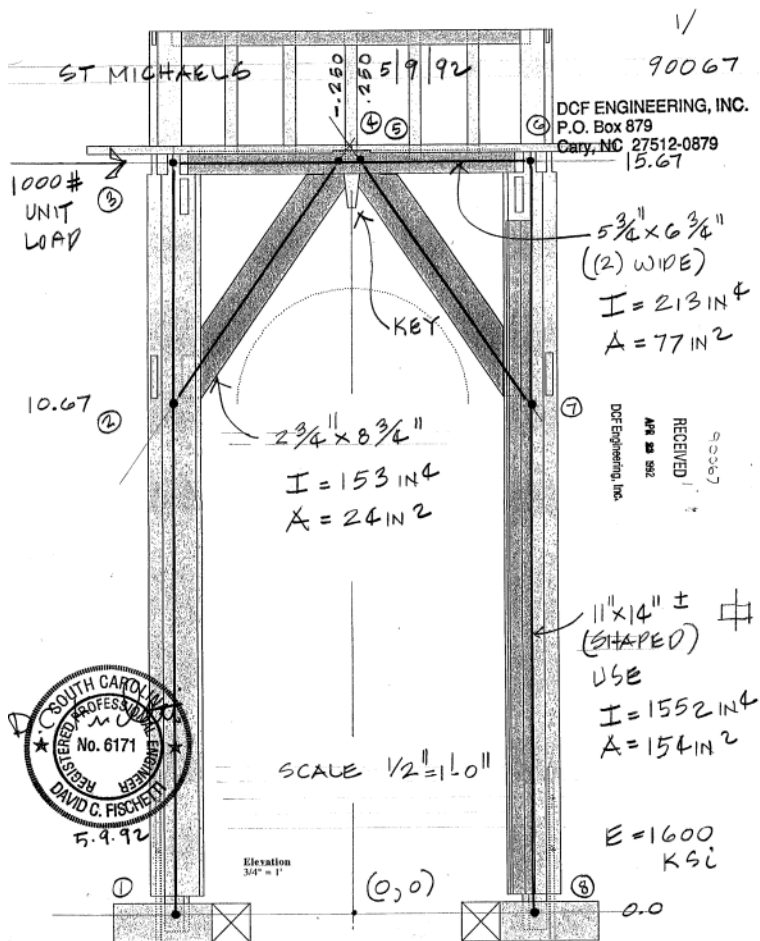
Fig. 5. Portal framing behind finish. Wedge descends through beam.

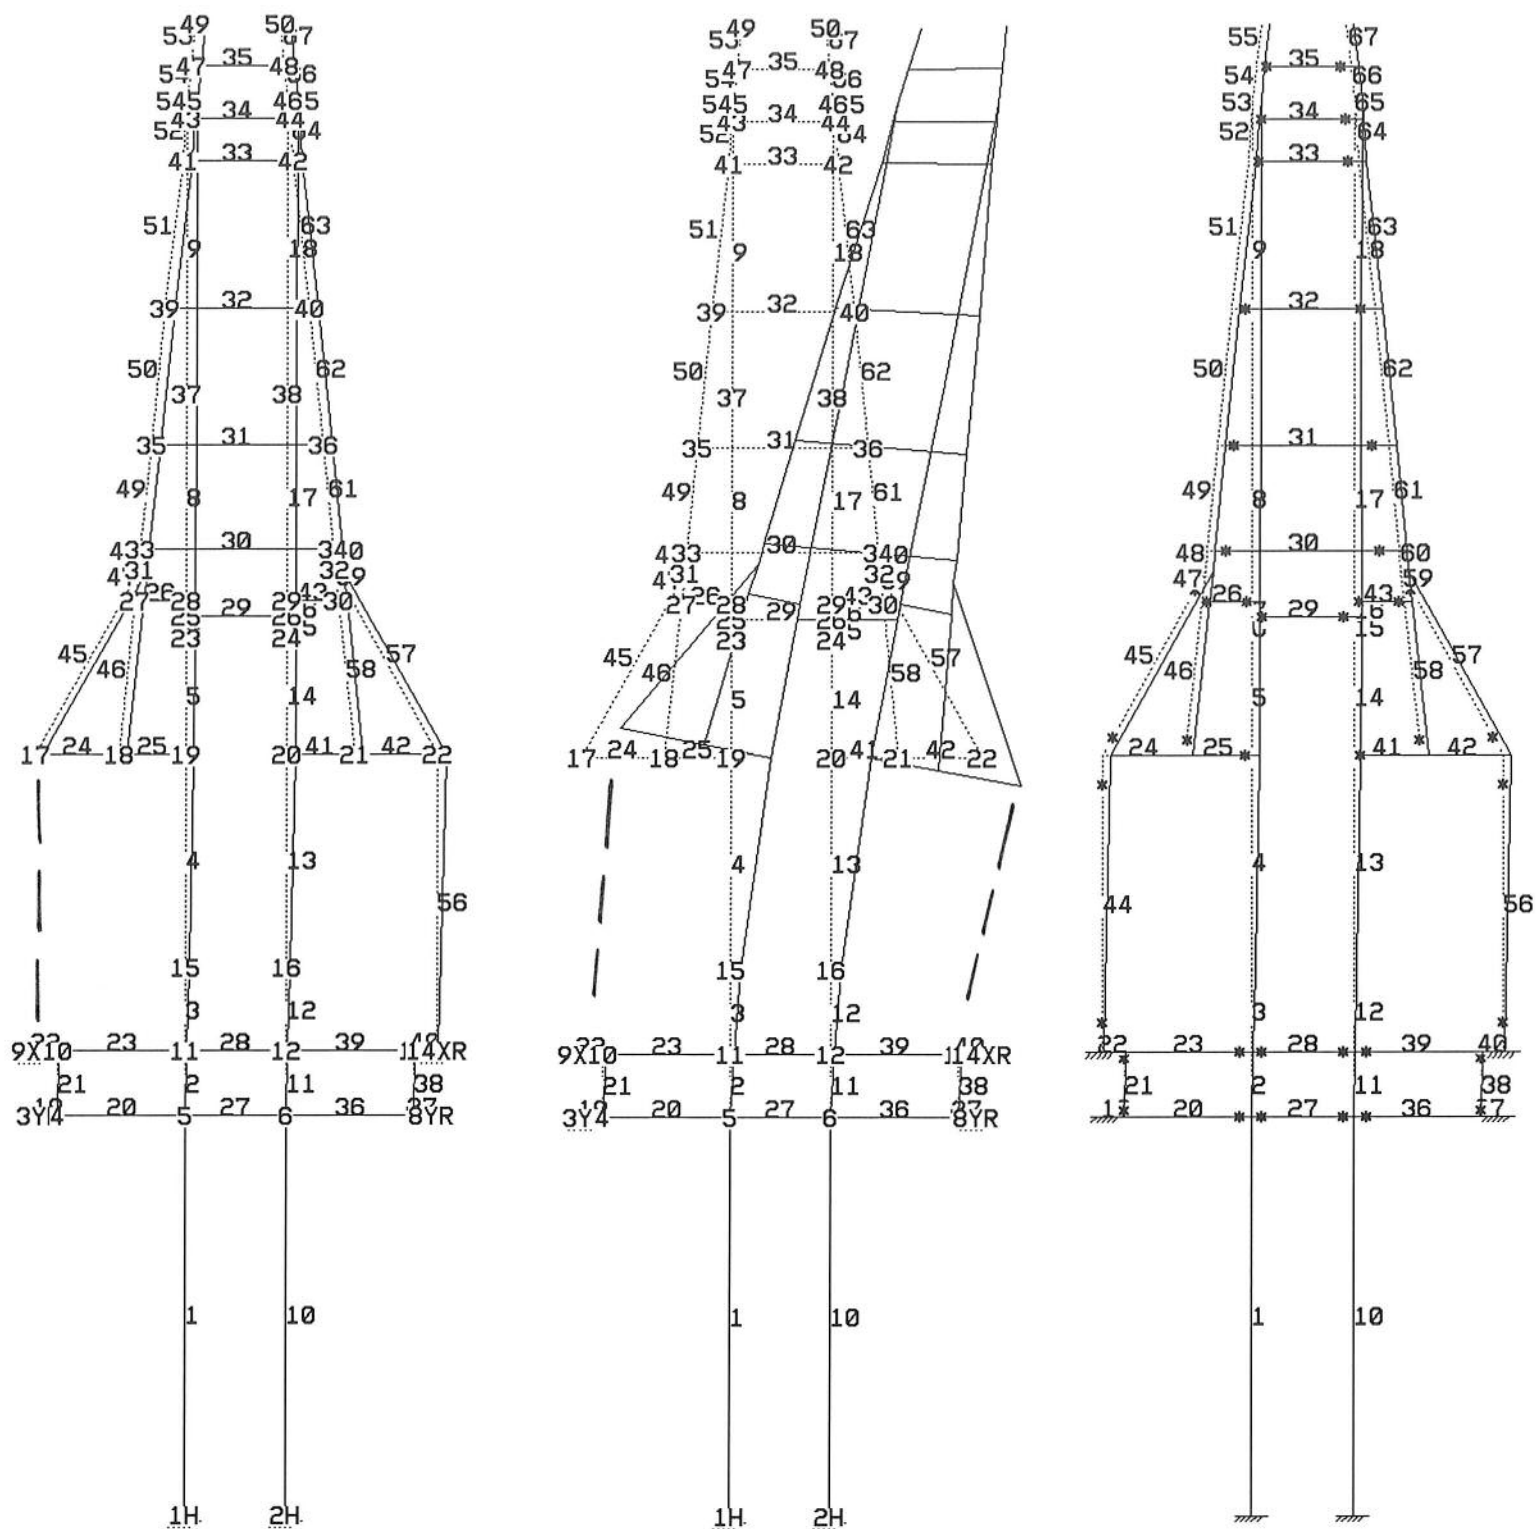
Fig. 8. Wind coming from the left in all cases, drawings represent behavior of a segment of the spire and lantern with the windward post disconnected (model at left, one broken line), windward and leeward posts disconnected (middle model, both broken lines) and both posts connected as built (model at right, solid lines).

At the same time, preliminary observation had indicated that the eight perimeter posts of the lantern had suffered varying amounts of deterioration where they tenoned into the radial floor beams, which would imply a diminution or actual lack of connection. The engineering analysis indicated that the spire frame responded much less stiffly to forces with these joints at the floor disconnected (Fig. 8).

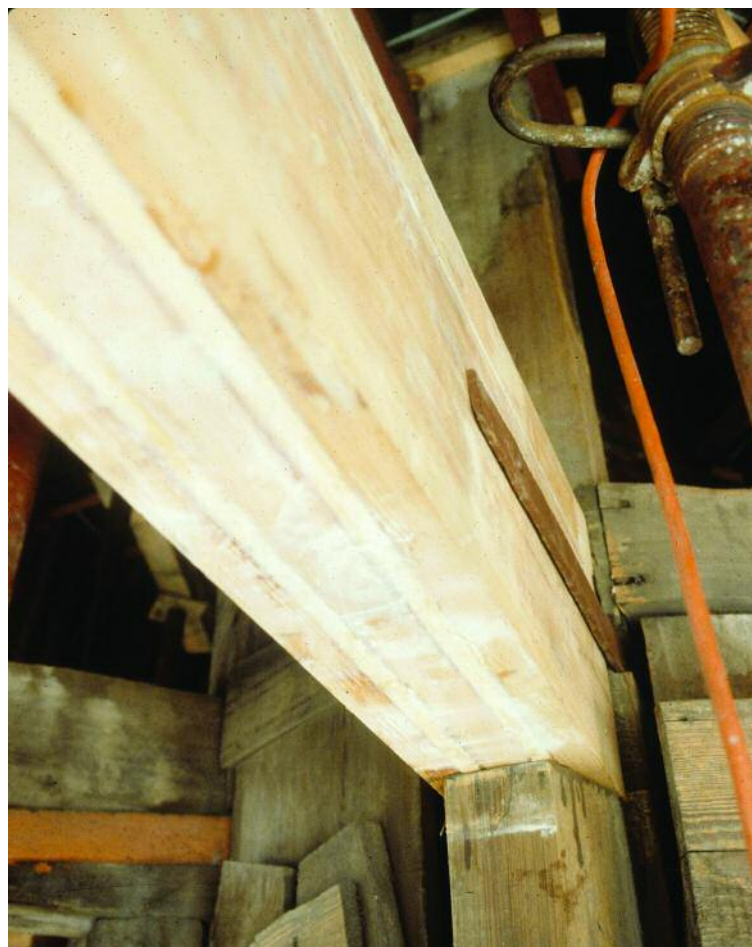
Fig. 15. Decayed perimeter post to spider beam connection under lantern floor.

New bottom tenons or tenoned ends as necessary for those perimeter posts that had deteriorated at the lantern floor were fabricated from dense cypress with a moisture content of 14 to 16 percent, close to the 11 to 14 percent moisture content of the original frame (Figs. 15-16).

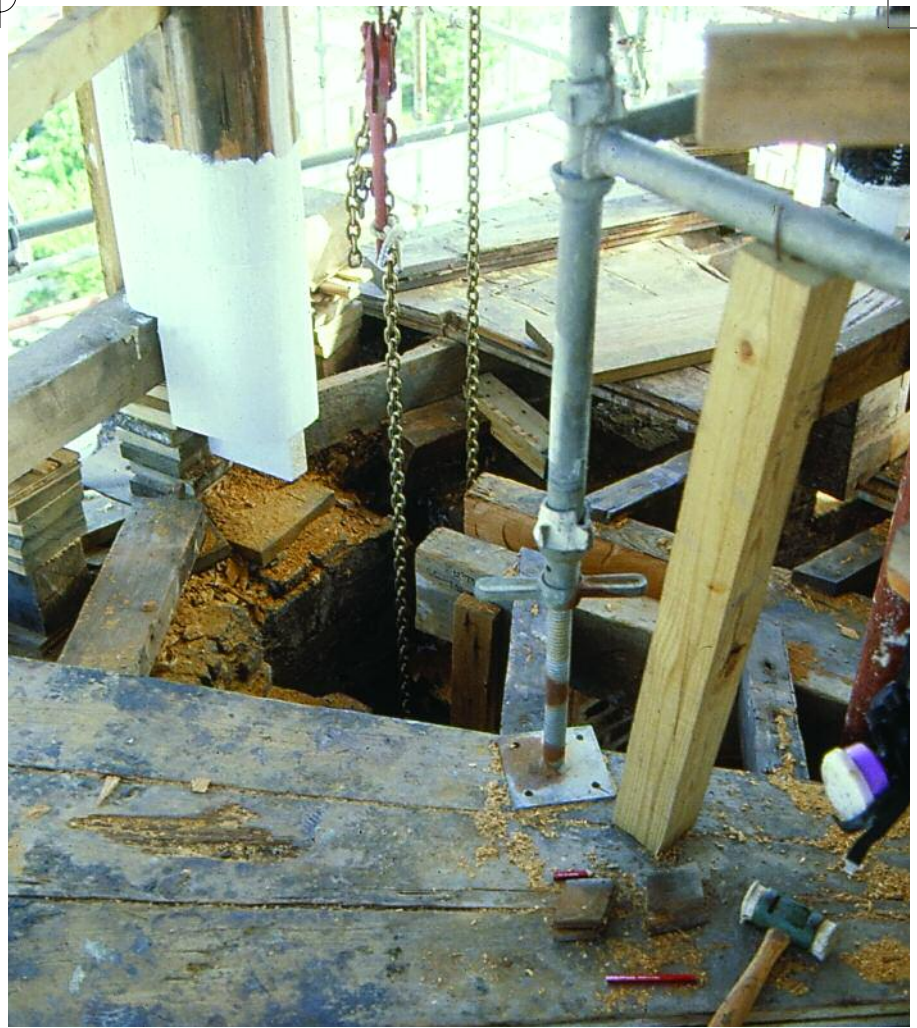
Fig. 17. Lantern floor peeled of its lead skin reveals splined and caulked floorboards and WSW end of one of the eight radial spider beams.

Where the radial 8x10 horizontal timbers (or spider beams as we called them) below the floor of the lantern were severely deteriorated, we replaced them with pressure-treated Southern yellow pine having a 2.5 pcf retention of copper chromated arsenate (CCA) water-borne preservative. These members, embedded 3 ft. deep inside the heavy masonry walls near the top of the clock stage and cantilevered toward the center across brick corbels, provided stabilization and some vertical support to the central spine of the spire. Wrought-iron straps throughout the steeple that had disintegrated too far to be reworked were replaced with stainless steel.
